## Pine64 “Woodpecker” USB UART adapter Product change note #1, December 2022

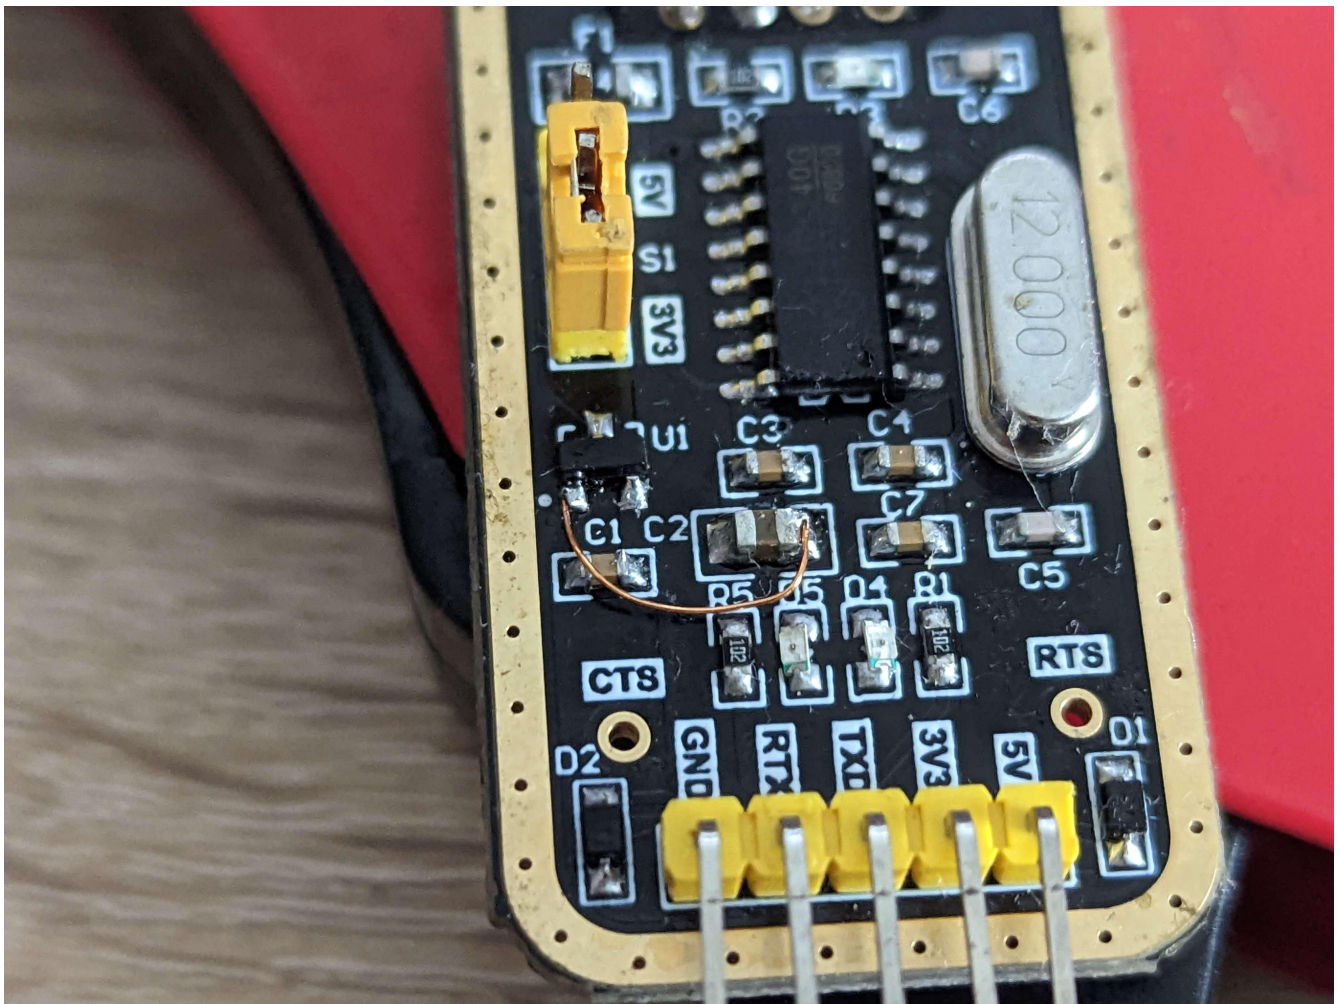
When the voltage mode selection jumper on the “Woodpecker” is placed in the 3.3 V position, the “Woodpecker” sometimes doesn’t work as expected and isn’t recognized at all by the host computer that it’s plugged into. The 5 V mode isn’t affected by this issue.

The root cause is a manufacturing defect that causes one of the pins of the 3.3 V LDO voltage regulator found on the “Woodpecker” not to be properly grounded. Consequently, the 3.3 V mode sometimes works, and sometimes it doesn’t. To fix this issue, the pin #1 (GND) of the 3.3 V voltage regulator needs to be connected to the nearest available ground, as illustrated in the picture below. Note that coil wire with special coating is used in the picture, but it is not mandatory; it’s only important not to short some other components on the PCB.
