Pine64 "Woodpecker" USB UART adapter Product change note #1, December 2022

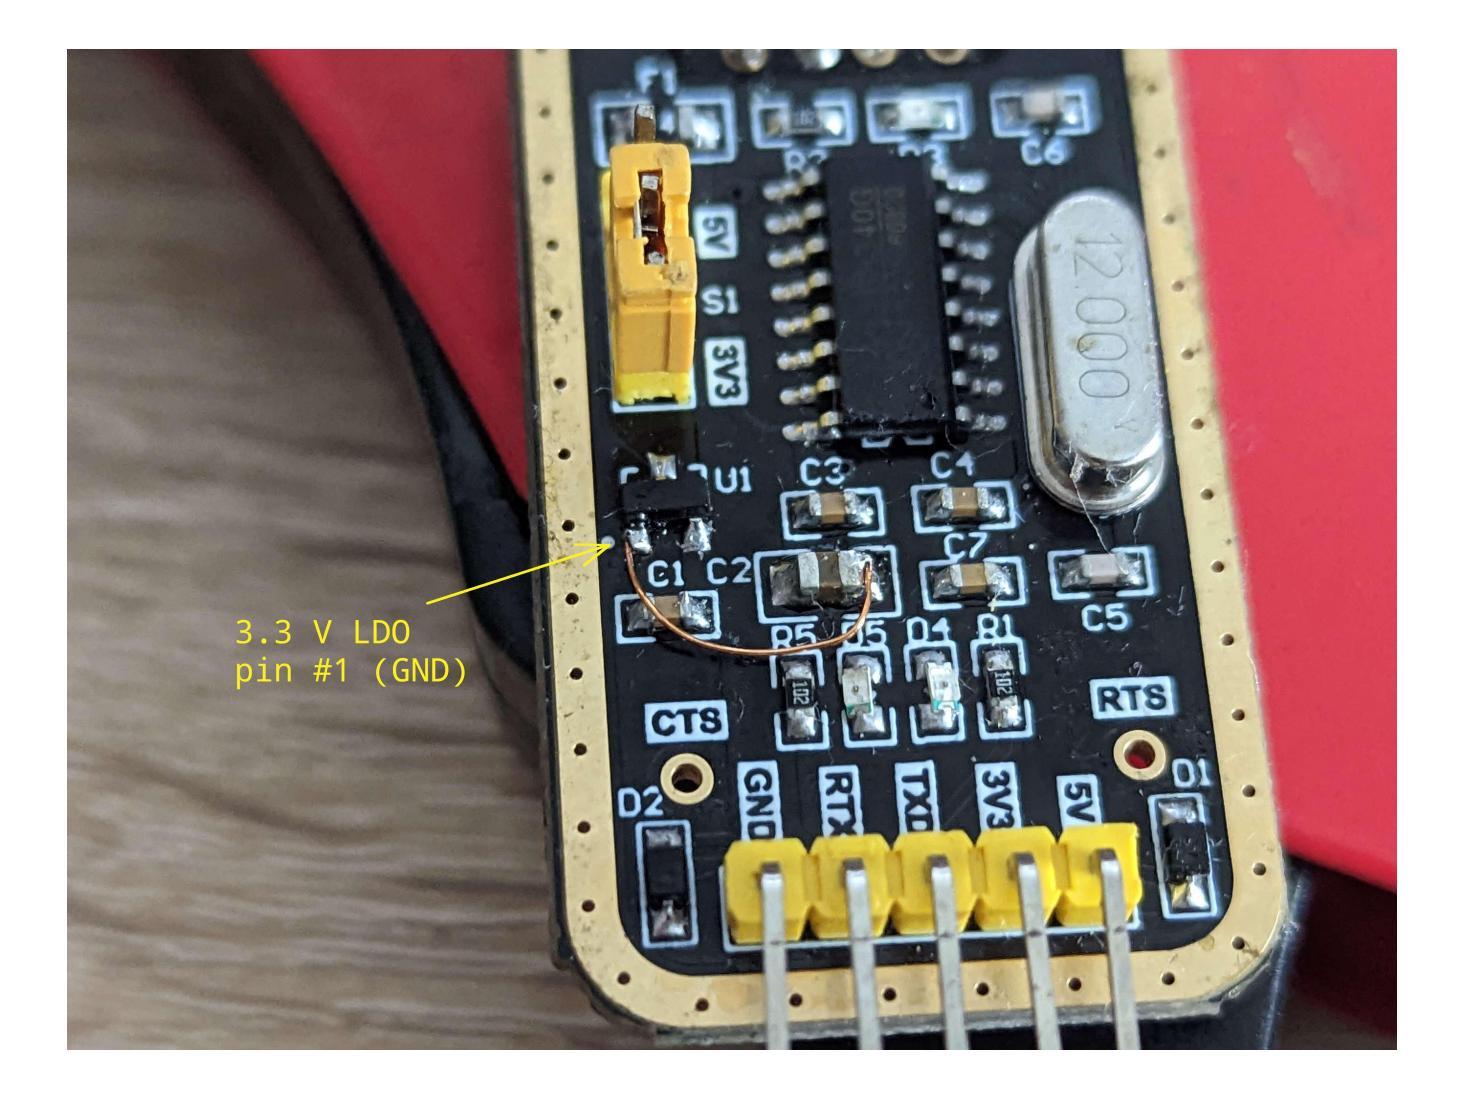
The root cause is a PCB design error that causes one of the pins of the 3.3 V LDO voltage regulator found on the "Woodpecker" not to be properly connected to the ground. Consequently, the 3.3 V mode of the adapter becomes unreliable, randomly failing to work as expected.

To check is your "Woodpecker" USB UART adapter affected by this issue, you can use a multimeter to check for missing continuity between the pin #1 (ground) on the 3.3 V LDO regulator and the GND pin on the five-pin UART header, which are all visible in the picture below. To fix this issue on affected "Woodpecker" PCBs, the pin #1 (ground) of the 3.3 V LDO voltage regulator needs to be connected to the nearest available ground, as illustrated in the picture below. Note that thin magnet coil wire with special lacquer coating is used in the picture, but that is not mandatory; it is only important not to short some other components on the PCB while applying the fix.

This issue has been corrected by a design change on the revised "Woodpecker" PCB.
